**Report on the cross border effects of the continuation of lignite mining in Turów (Poland) on  
water in Germany**

Sylwester Kraśnicki, Ph. D.

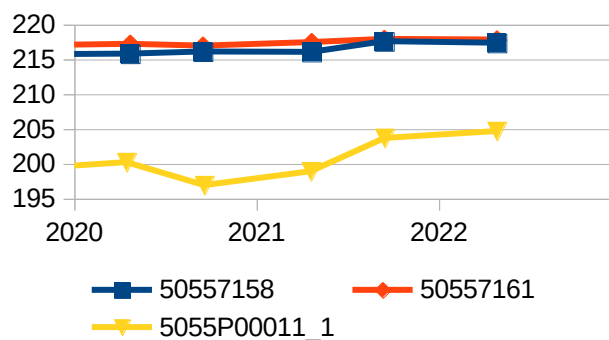
The amplitude of groundwater table fluctuations throughout the observation period was 1.5-50 meters, and in the period 2020-2022, it was 0.25-8 m. If in 2020-2022, a water table changes its position by at least 1 meter, the change can be considered an important trend. In three hydrogeological wells (50557158, 50557161 and 5055P00011\_1), the groundwater table rise by more than 1 meter was observed (Fig.4).

Fig. 4. The water table rise in the monitoring wells no.: 50557158, 50557161 and 5055P00011\_1.

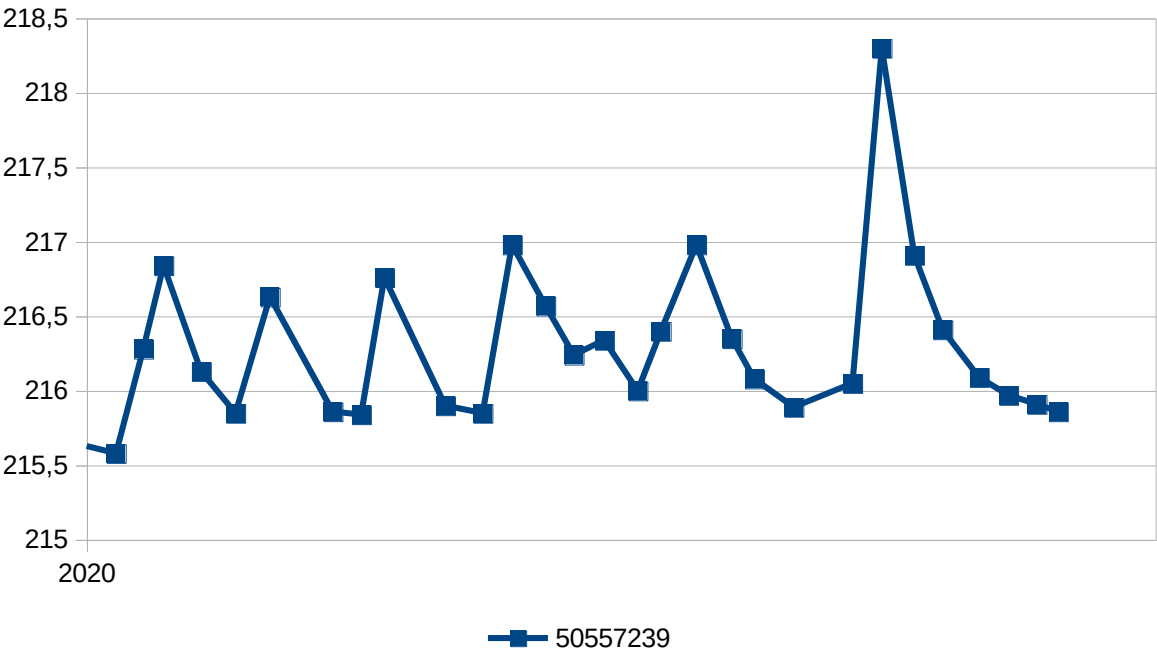
No groundwater table drop was observed in any of the boreholes. In the remaining 17 wells, no significant trend of changing the position of the groundwater table was observed (Fig 5) or this trend was ambiguous, and there was observed its rise and drop (Fig 6).

Fig. 5. The water table changes in the monitoring well No. 50557239.

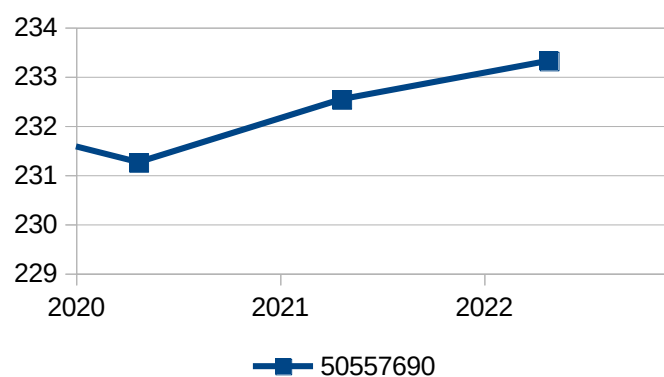
Most of the monitoring points are located in the Nysa Łużycka valley, but several points are located in other parts of the described area. The amplitude of water table fluctuations during the entire observation period was 2.5-30 meters, and in the years 2020-2022, it was 0.2-15 m. In many points, a large rise of the water table is observed throughout the entire observation period. In the period 2020-2022, the rise of the groundwater table by more than 1 meter was observed in 7 hydrogeological wells (Fig.8).

Fig. 8. The water table changes in the monitoring well No. 50557690.

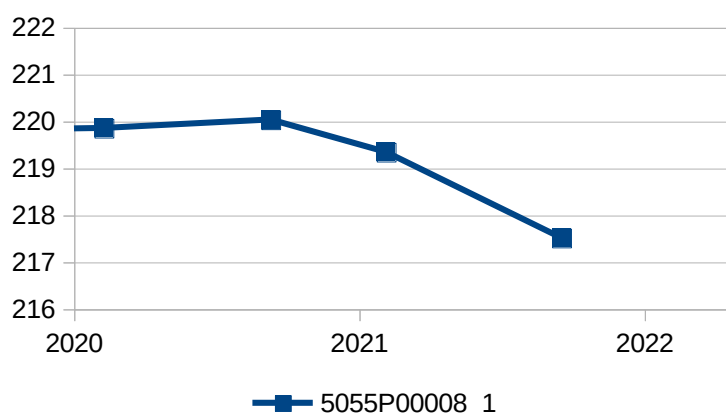
The groundwater table drop was observed in well no. 5055P00008\_1. In this well, the groundwater table rise was also observed throughout the observation period, and its drop was observed in 2021. In this hydrogeological node, there are three wells (5055P00008\_1, 5055P00008\_2 and 5055P00008\_3), of which only in the first one the lowering of the groundwater table was observed. The well 5055P00008\_2 monitors another groundwater layer in this aquifer, but this, in turn, has experienced a groundwater table rise.

Fig. 9. The water table changes in the monitoring well No. 5055P00008\_1.

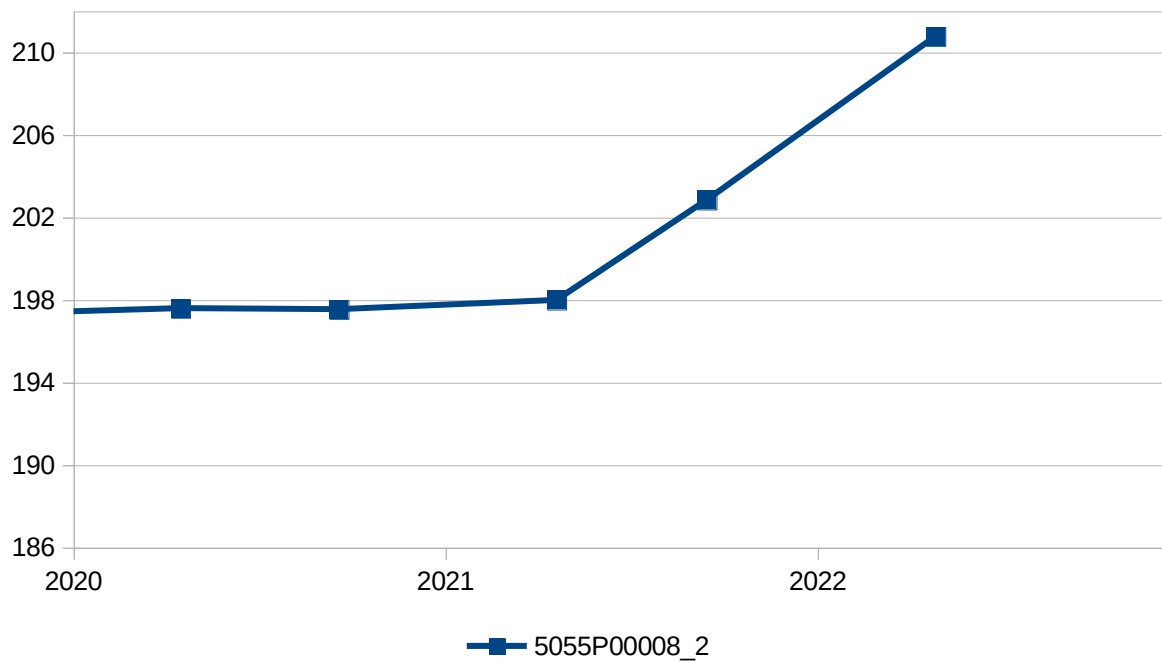
On the other hand, the well 5055P00008\_3 monitors the aquifer GWL OU, and there the trends were ambiguous in 2020-2022. In this situation, it is difficult at present to ascribe the lowering of the groundwater table in the borehole 5055P00008\_1 to the drainage of the lignite deposit exploited by the Turów mine since, in the remaining two wells, such drop is not observed, but its observations should be continued (Fig.9 -11). According to the author of the report, the reason may be a leakage of the insulating layer built of clays between the wells 5055P00008\_1 and 5055P00008\_2 because, at the same time, in the second well, the groundwater table rises.

Fig. 10. The water table changes in the monitoring well No. 5055P00008\_2.

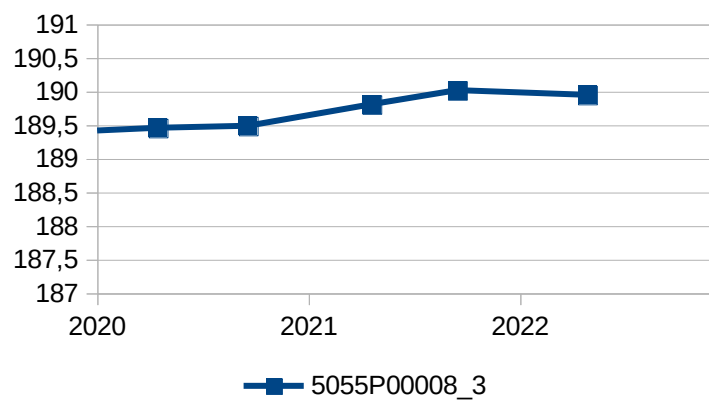
Fig. 11. The water table changes in the monitoring well No. 5055P00008\_3.

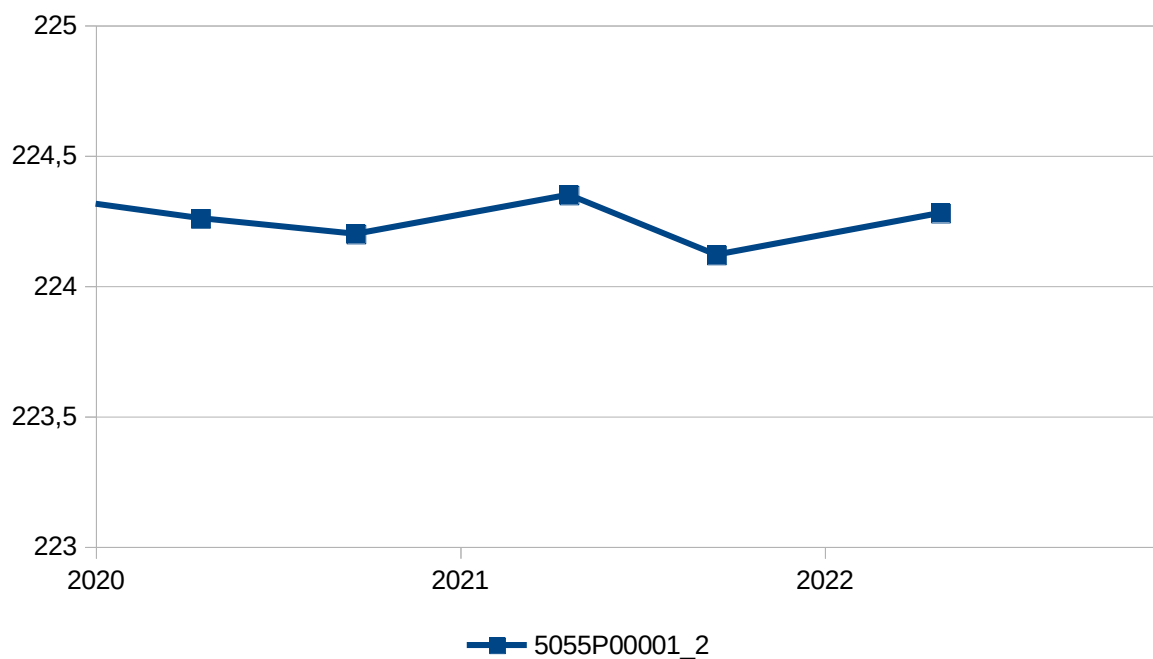
In the remaining boreholes, no significant trend of changing the position of the groundwater table was observed (Fig. 12) Or this trend was ambiguous, and there was a rise and drop of the groundwater table (Fig. 13).

Fig. 12. The water table changes in the monitoring well No. 5055P00001\_2.

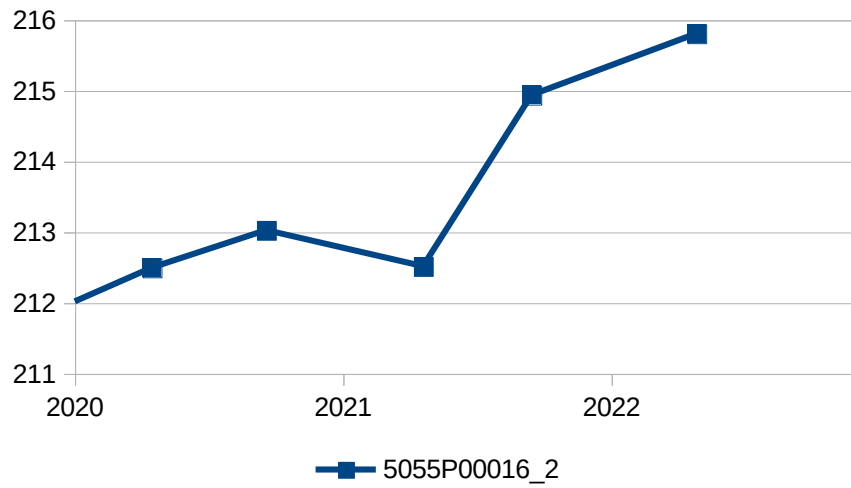
Most of the monitoring points are located in the Nysa Łużycka valley on the Polish side. The amplitude of the groundwater table fluctuations throughout the observation period was 2-20 meters, and in the years 2020-2022, it was 0.2-3.5 m. In the period 2020-2022, only in the hydrogeological well No. 5055P00016\_2, the groundwater table rise by more than 1 meter was observed (Fig. 15). No groundwater table drop was observed in this aquifer.

Fig. 15. The water table changes in the monitoring well No. 5055P00016\_2.

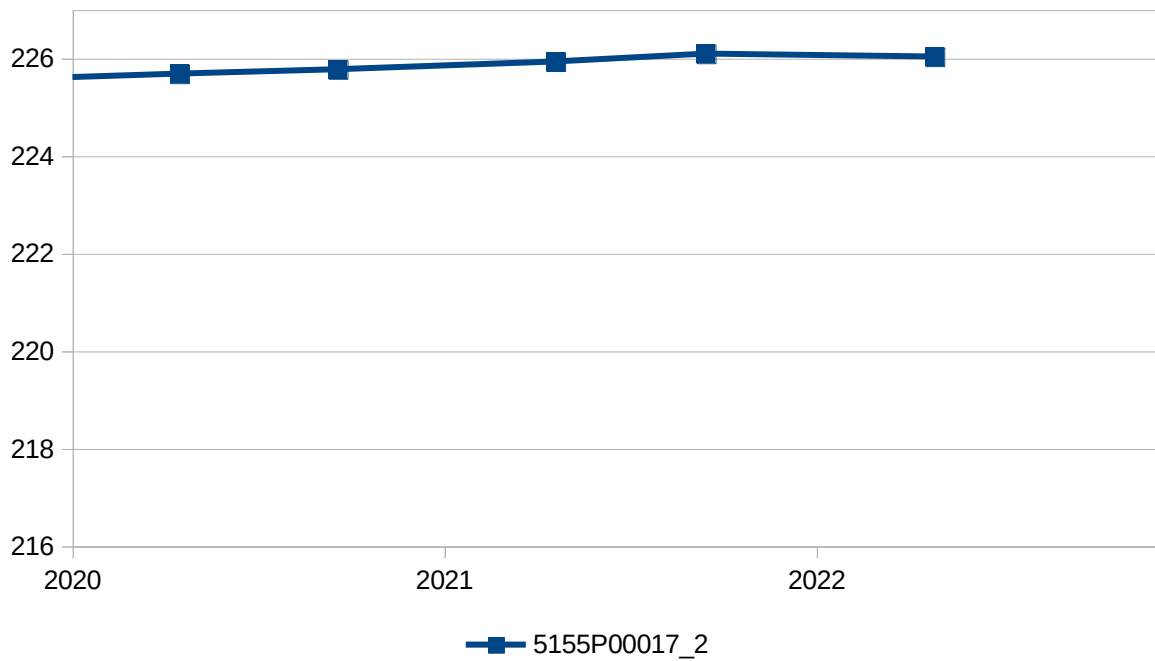
In the remaining wells, no significant trend of changing the position of the groundwater table was observed (Fig. 16).

Fig. 16. The water table changes in the monitoring well No. 5155P00017\_2.

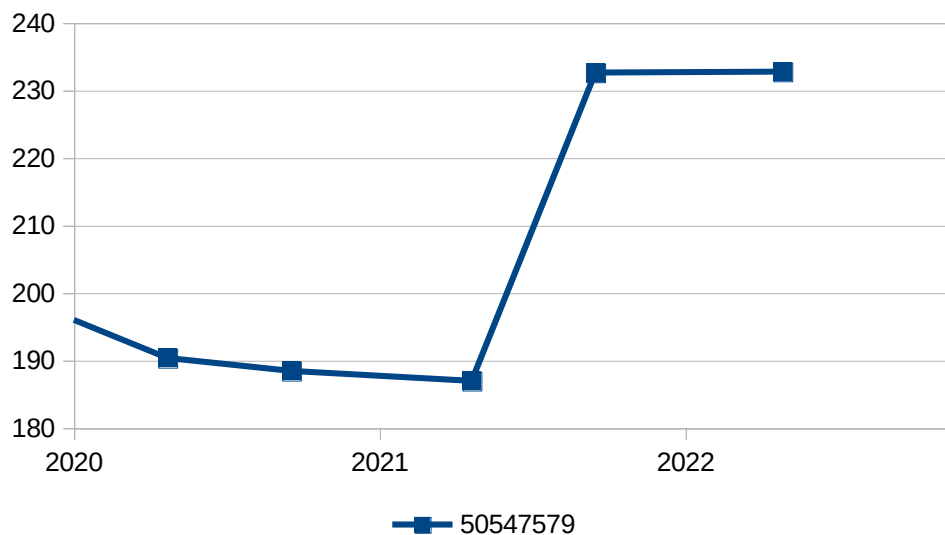
Most of the monitoring points are located in the Nysa Łużycka valley. The amplitude of groundwater table fluctuations throughout the observation period was 4.5-50 meters, and in the years 2020-2022, it was 0.2-45 m. A record-high groundwater table rise took place in well no. 50547579 in 2021, reaching maximum values throughout the entire observation period. (Fig.18) In the period 2020-2022, the rise of the groundwater table by more than 1 meter was observed in 5 hydrogeological wells (Fig.19). No groundwater table drop was observed at this aquifer.

Fig. 18. The water table changes in the monitoring well No. 50547579.

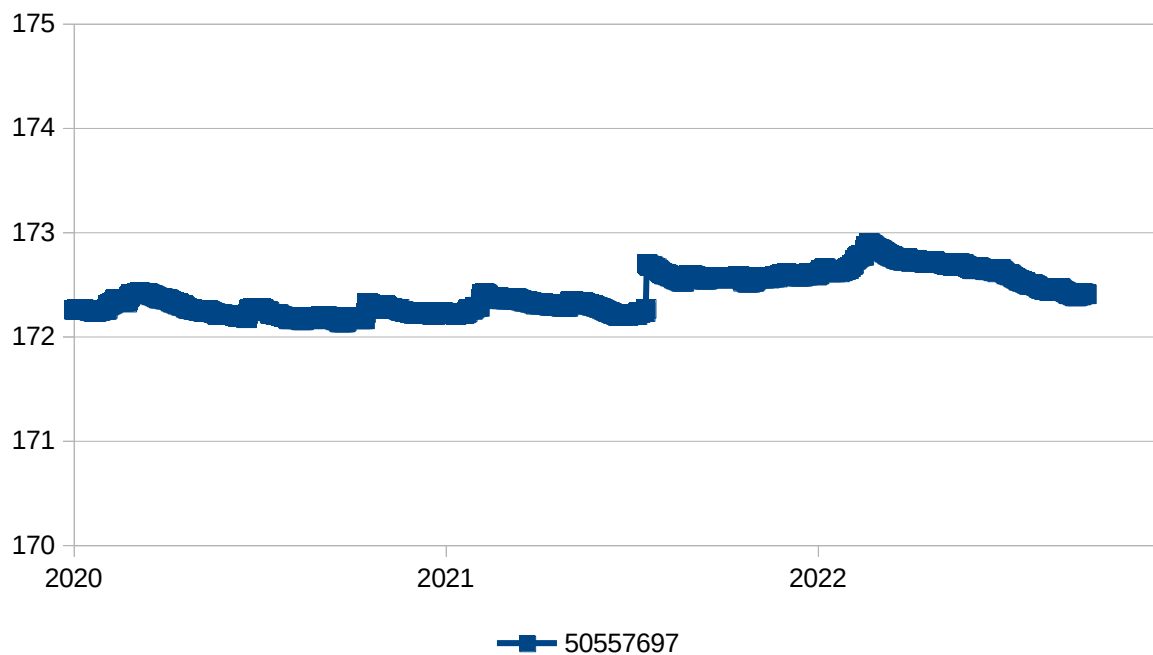
In the remaining wells, no significant trend of changing the position of the groundwater table was observed or this trend was ambiguous, and there was a rise and drop of the groundwater table (Fig. 19).

Fig. 19. The water table changes in the monitoring well No. 50557697.

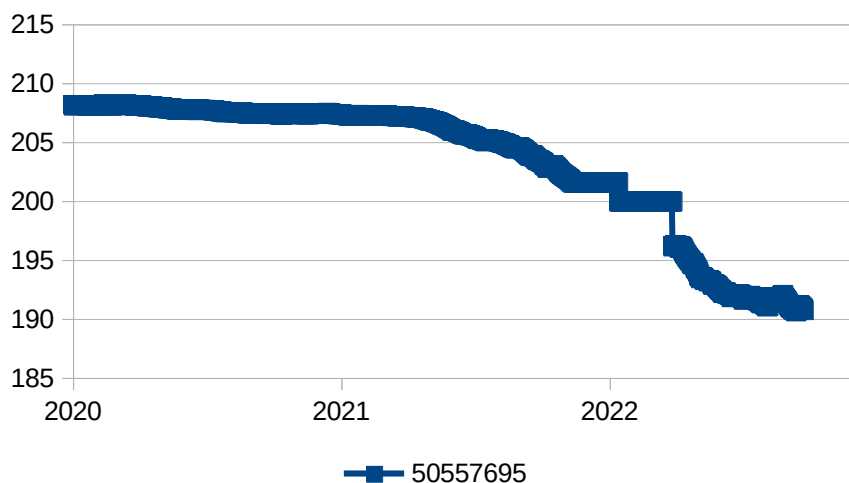
Most of the monitoring wells are located in the Nysa Łużycka valley, but numerous wells are also located in the area of the town Zittau. The amplitude of groundwater table fluctuations throughout the observation period was 2.5-75 meters, and in the years 2020-2022, it was 0.3-18 m reaching minimal values over the entire observation period. (Fig. 21). In the period 2020-2022, the rise of the groundwater table by more than 1 meter was observed in 5 hydrogeological wells (Fig. 22).

Fig. 21. The water table changes in the monitoring well No. 50557695.

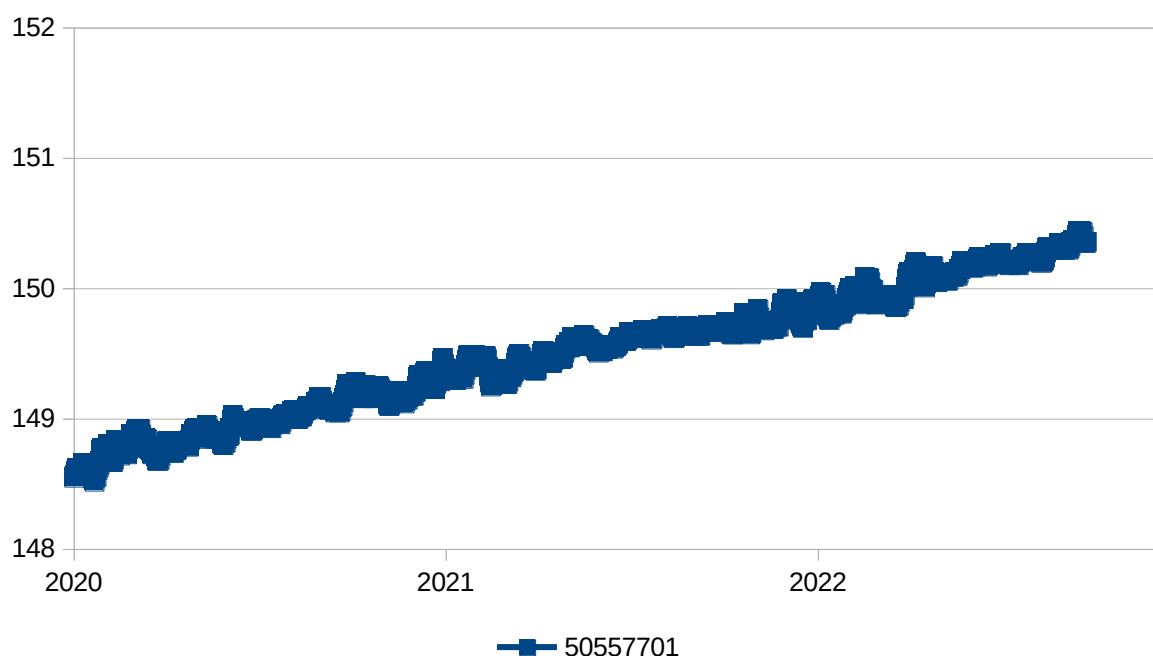
Fig. 22. The water table changes in the monitoring well No. 50557701.

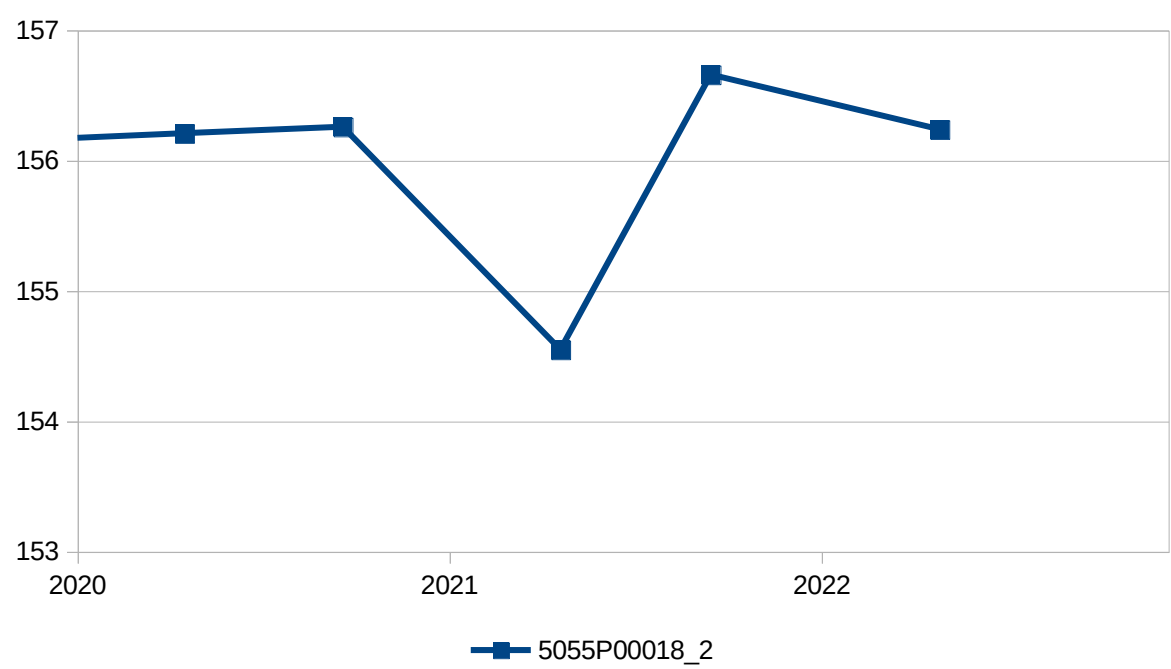
wall length is insufficient. In the remaining boreholes, no significant trend of changing the position of the groundwater table was observed or this trend was ambiguous, and the groundwater table rose and dropped (Fig. 23).

Fig. 23. The water table changes in the monitoring well No. 5055P00018\_2.

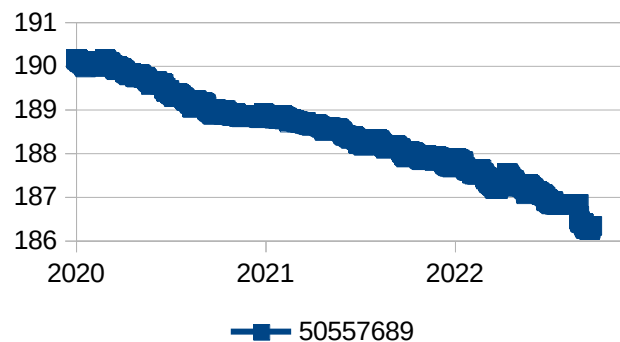
All monitoring wells of this aquifer are located in the German part of the Zittau basin. The amplitude of the groundwater table fluctuations during the entire observation period was 4-90 meters, and in the years 2020-2022, it was 0.3-14 m. In this aquifer, the most significant drop of the groundwater table is observed. A record-breaking lowering of the groundwater table took place in well no. 50557689, from 2020, it dropped by 14 meters (Fig. 25).

Fig. 25. The water table changes in the monitoring well No. 50557689.

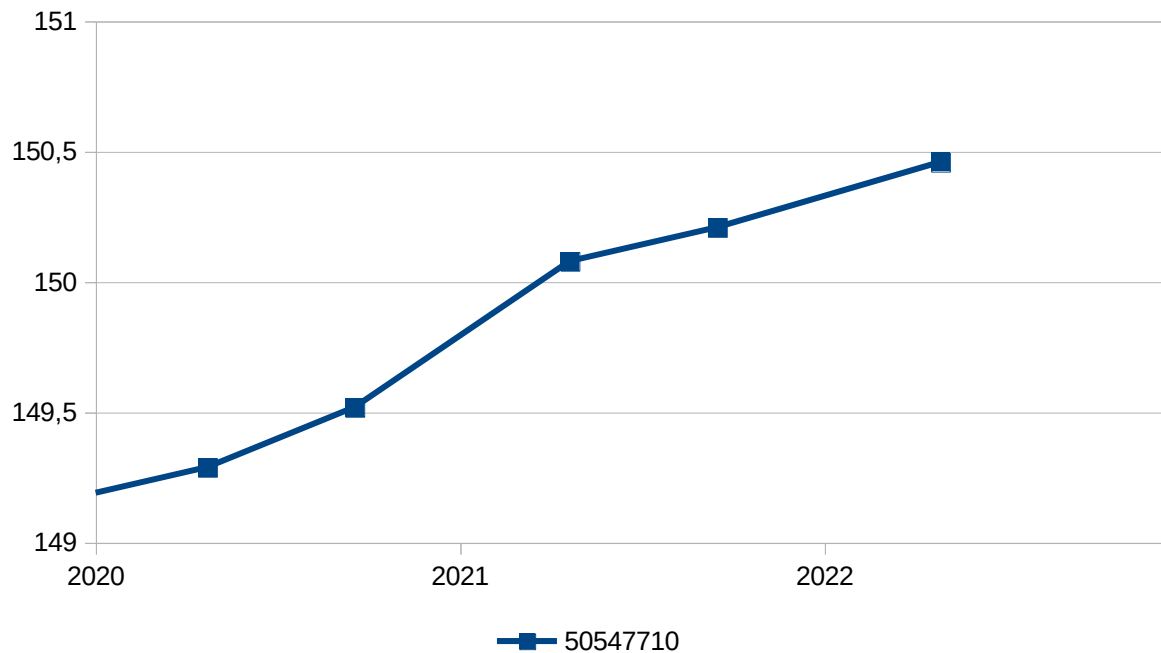
In the period 2020-2022, in two hydrogeological wells (50557700 and 50547710), the groundwater table rise by more than 1 meter was observed (Fig. 26). On the other hand, in two hydrogeological wells (50557689 and 51547708), the groundwater table drop was observed (Fig.?).

Fig. 26. The water table changes in the monitoring well No. 50547710.

This is a continuation of the unfavourable trends described in the Krupp report (Krupp 2020). As in the case of the ZiC aquifer drainage, the groundwater table drop in 2020-2022 is observed in Zittau and south of Hirschfelde, i.e. south and north of the anti-filtration screen built along the Łużycka Nysa. On the other hand, the rising of the groundwater table was observed in the wells behind the screen. In the remaining boreholes, no significant trend of changing the position of the groundwater table was observed or this trend was ambiguous, and the groundwater table rose and dropped (Fig. 27).

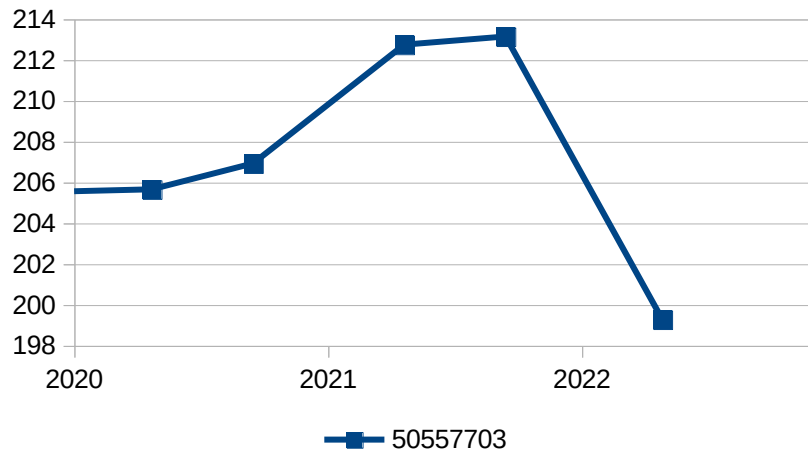
Fig. 27. The water table changes in the monitoring well No. 50557703.

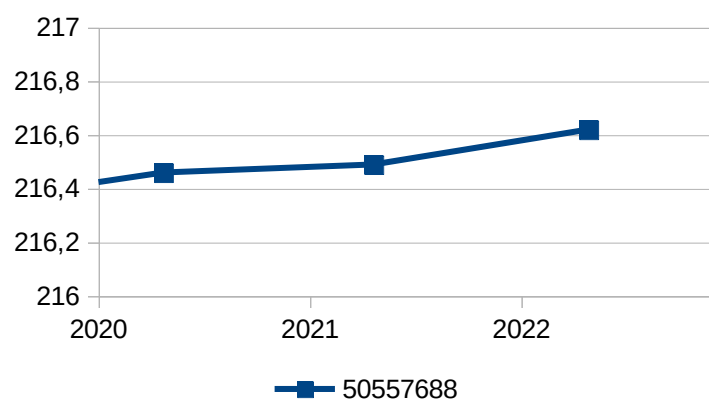
In the wells located in the northern part of the Zittau basin area (50557688, 50557698 and 5055P00003\_1), a rise of the groundwater table was observed in 2020-2022. During the entire observation period, no clear trends in changes in the position of the groundwater table in these wells were found because it was both dropping and rising. In turn, in the wells located south of them (51547711 and 5055P00022) (Fig. 29), the groundwater table drop was observed during this period, and this is a continuation of the downward trend of the groundwater table throughout the observation period. They monitor deep aquifers (GWL VBaZ and GWL PGDZ) in the southern part of Zittau and are located in an area where the aquifers of GWL ZiC and GWL ZU are also drained (Fig. 30). In well No. 5055P00003\_1, no observations were carried out in the years 2020-2022, while in the entire observation period (1990-2013), a weak trend of rising groundwater table was observed.

Fig. 29. The water table changes in the monitoring well No. 50557688.

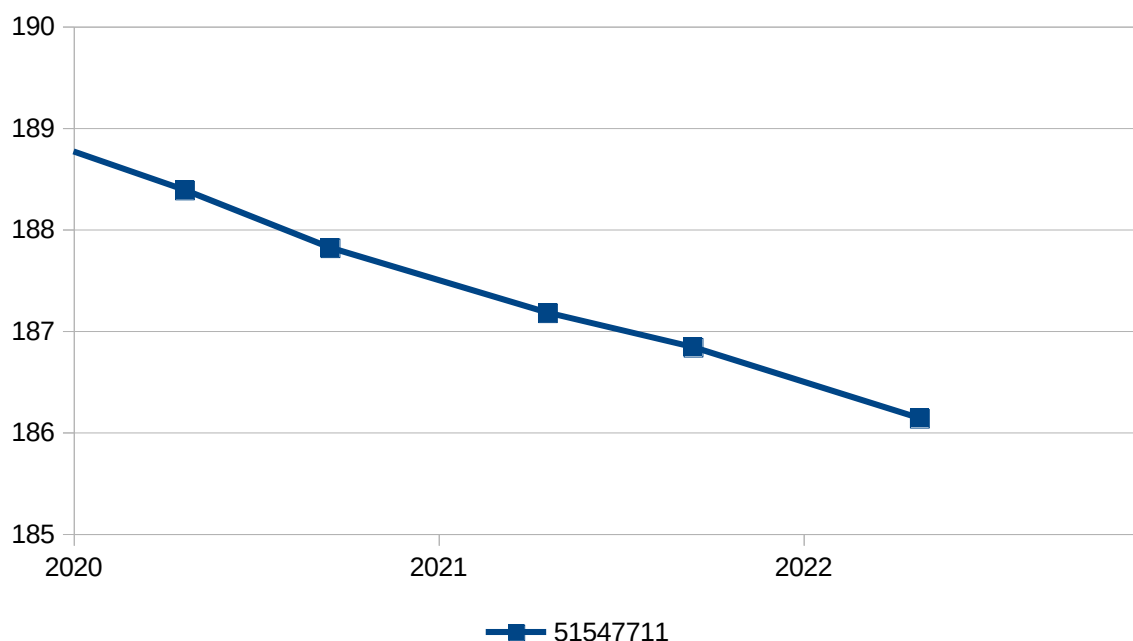
Fig. 30. The water table changes in the monitoring well No. 50557711.
